## HANGING MARKS

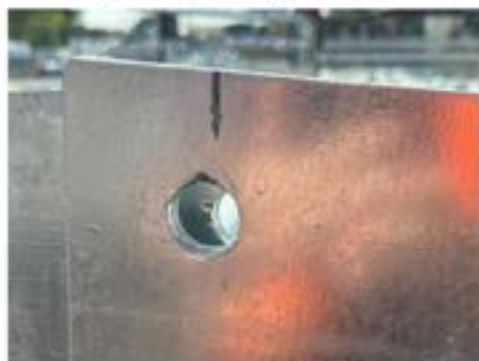
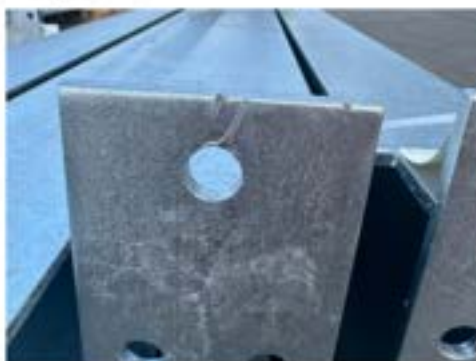
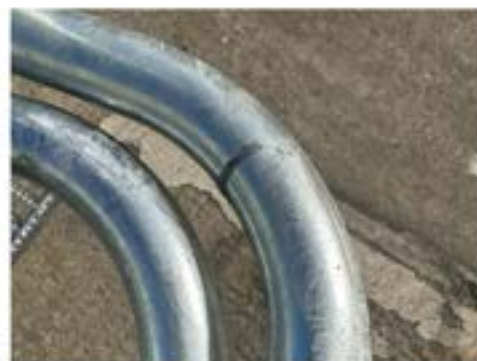
Zinc solidifies at 420°C, meaning once the item is withdrawn from the galvanizing bath the molten metal hardens almost immediately. This can lead to zinc being trapping around the point at which the item was hung, leaving a small mark in this area. The galvanizing reaction is a unique one where the molten zinc chemically reacts with the base metal to form a protective coating. It is also sacrificial by nature, meaning the zinc will corrode in preference to the base metal, preventing corrosion at that point.

These marks are common feature of Hot Dip Galvanizing and are not detrimental to the overall protection of the material, however if required, can be repaired using a good quality zinc rich paint as recommended by **BS EN ISO 1461 - 2022 - article 6.3 Renovation**.
