# TRUSS FABRICATIONS

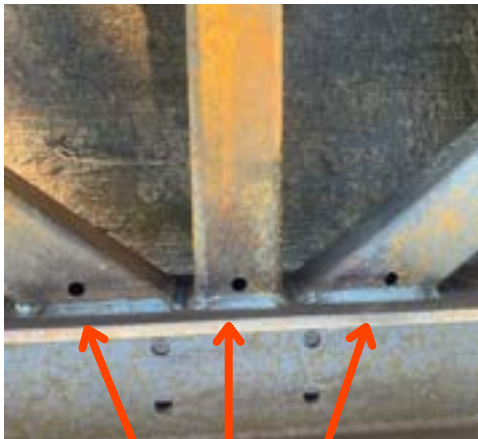
These holes should be inline with the frame.

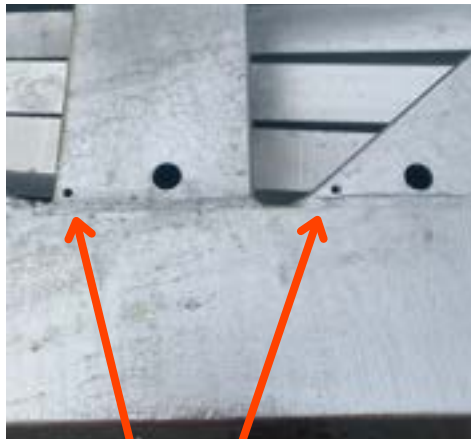
Extra holes will be required.

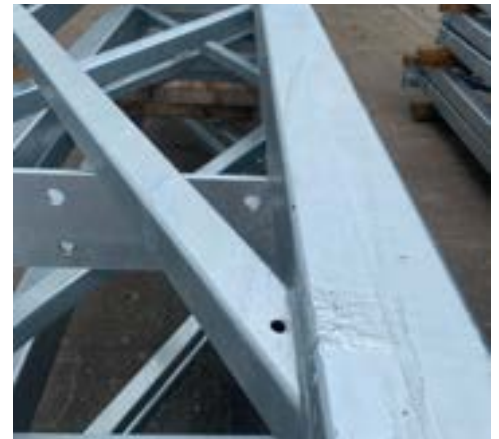
Poor position can lead to zinc runs.

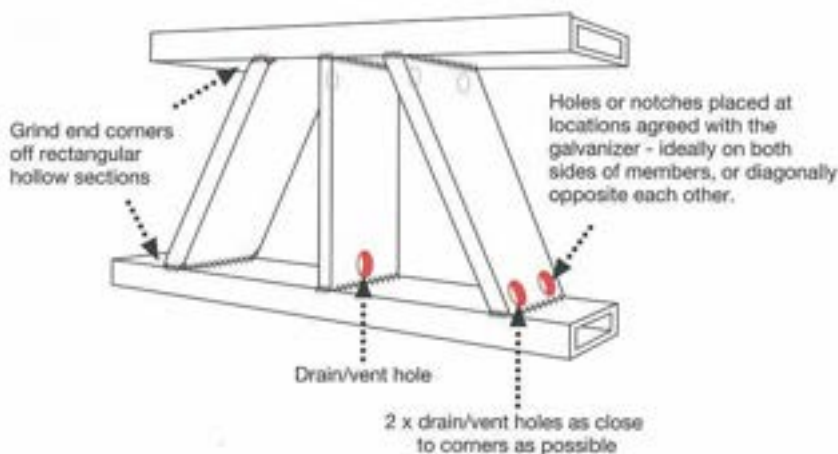
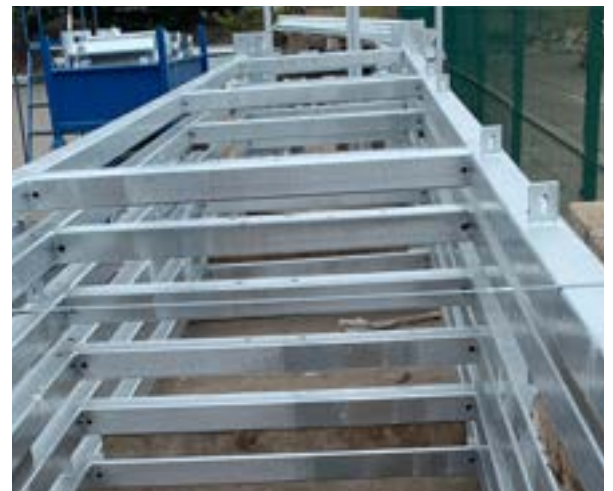
Good inline hole position

The diagram below illustrates the correct positioning of holes and suggests the options that can be used.
