## MATERIAL WITH INTERNAL PAINT CONTAMINATION

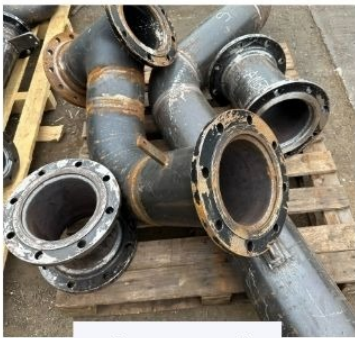
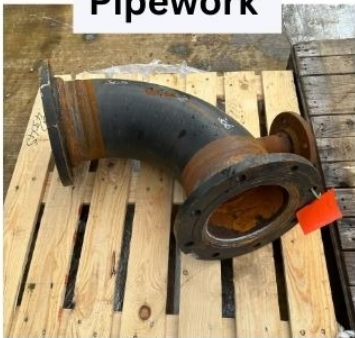
**Pipework**

Illustrated above are some common types of material with paint contamination on them that we are now **unable** to process. The internal and external paint contamination on these types of articles will have to be removed prior to galvanizing by either shotblasting or chemical stripping. This will then allow our acid pickling to clean your material and for the zinc to react to form the galvanized coating.

**So please ensure your material has no paint contamination internally and has been either completely shot-blasted or chemically stripped prior to arrival. Should you have such material please contact our design team for advice on what to do before sending it for galvanizing.**
