## HANGING MARKS

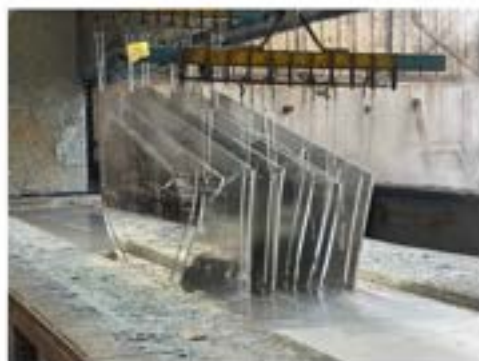
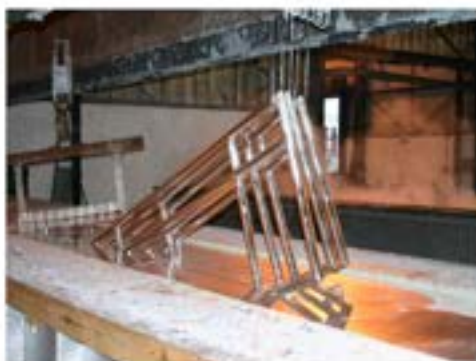
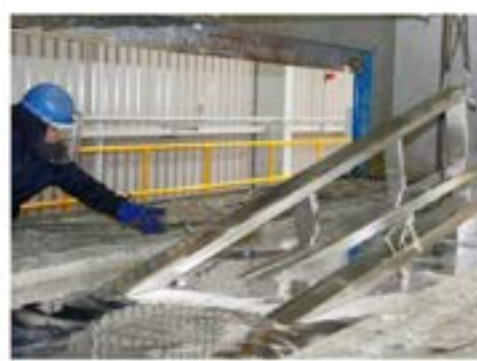
We are constantly aiming to improve our service and this information is aimed at providing customers with an insight to our Galvanizing process. Hot-dip galvanizing is the process of coating steel fabrications with zinc to prevent corrosion. During this process the fabricated steel is immersed in a bath of molten zinc at a temperature of around 450°C (840 °F). In order for this to be carried out all material must be securely and safely suspended for dipping into the galvanizing bath. This is commonly carried out using hooks or chains but is predominantly done by wire, as shown below.

Zinc solidifies at 420°C, meaning once the item is withdrawn from the galvanizing bath the molten metal hardens almost immediately. This can lead to zinc being trapping around the point at which the item was hung, leaving a small mark in this area. The galvanizing reaction is a unique one where the molten zinc chemically reacts with the base metal to form a protective coating. It is also sacrificial by nature, meaning the zinc will corrode in preference to the base metal, preventing corrosion at that point.

These marks are common feature of Hot Dip Galvanizing and are not detrimental to the overall protection of the material, however if required, can be repaired using a good quality zinc rich paint as recommended by **BS EN ISO 1461 - 2022 - article 6.3 Renovation**.
