REPAIRS TO GALVANIZED STEEL

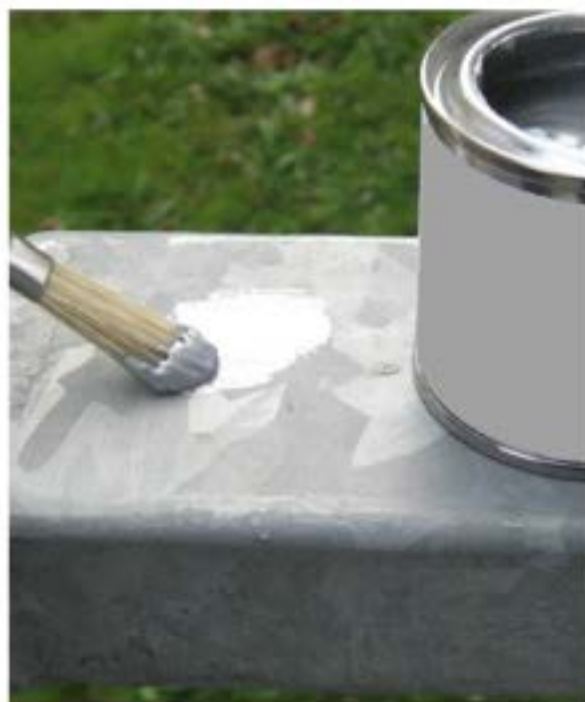
In practice, most repairs are conducted using a zinc-rich paint which might be brush or aerosol applied. It is also common to use a sprayed final top coat to attain a more aesthetic finish. Ideally the product used should contain at least 80% zinc by weight, the key being to follow the manufacturer's instructions and ensure sufficient coatings are applied to achieve the 100 µm repair coating thickness requirement of BS EN ISO 1461: 2022.
